CONTINUATION OF SURFACE WATER QUALITY MONITORING TO SUPPORT THE IMPLEMENTATION OF THE LAMPASAS RIVER WATERSHED PROTECTION PLAN

Final Report

TSSWCB Project # 19-54

Prepared by Texas A&M AgriLife Research

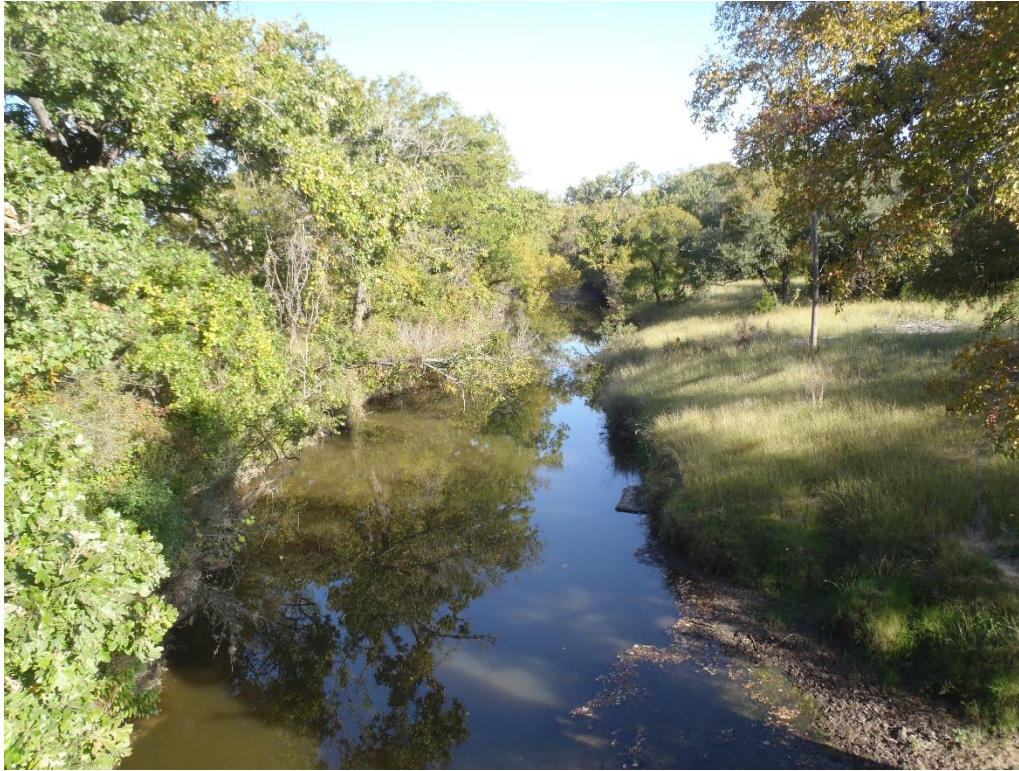
Figure 4 Station 15762, Lampapas River at US 84, looking upstream from sampling location on October 13, 2020.

The Lampasas River at US Hwy 84 monitoring site (station 15762, **Error! Reference source not found.** and Figure 5) is located in the northern portion of the watershed in western Hamilton County and is the most upstream sampling location. The upstream drainage area is primarily rangeland and is approximately 56 square miles. From November 2019 thru February 2020, no samples were collected due to insufficient pool size per TCEQ SWQM standards. Out of 13 routine samples collected during the project period, 3 were collected in pools and 6 events collected no samples due to insufficient pool size. In addition, 1 biased flow sample was not collected due to an insignificant pool as well.

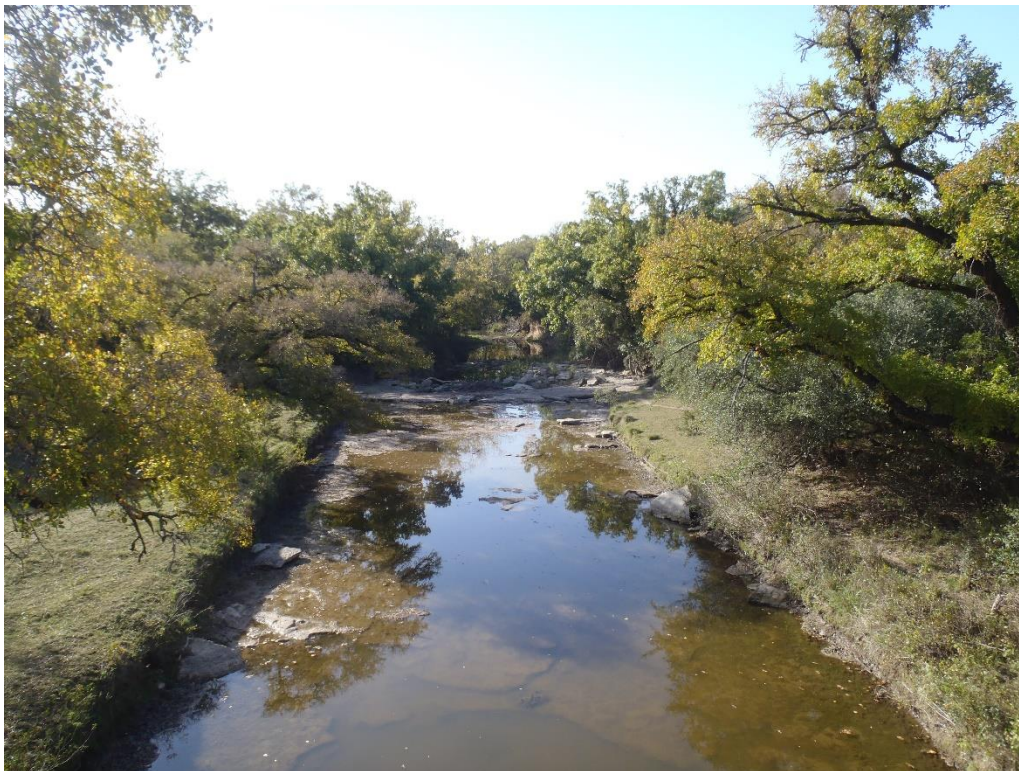
Figure 5 Station 15762, Lampapas River at US 84, looking downstream from sampling location on October 13, 2020.

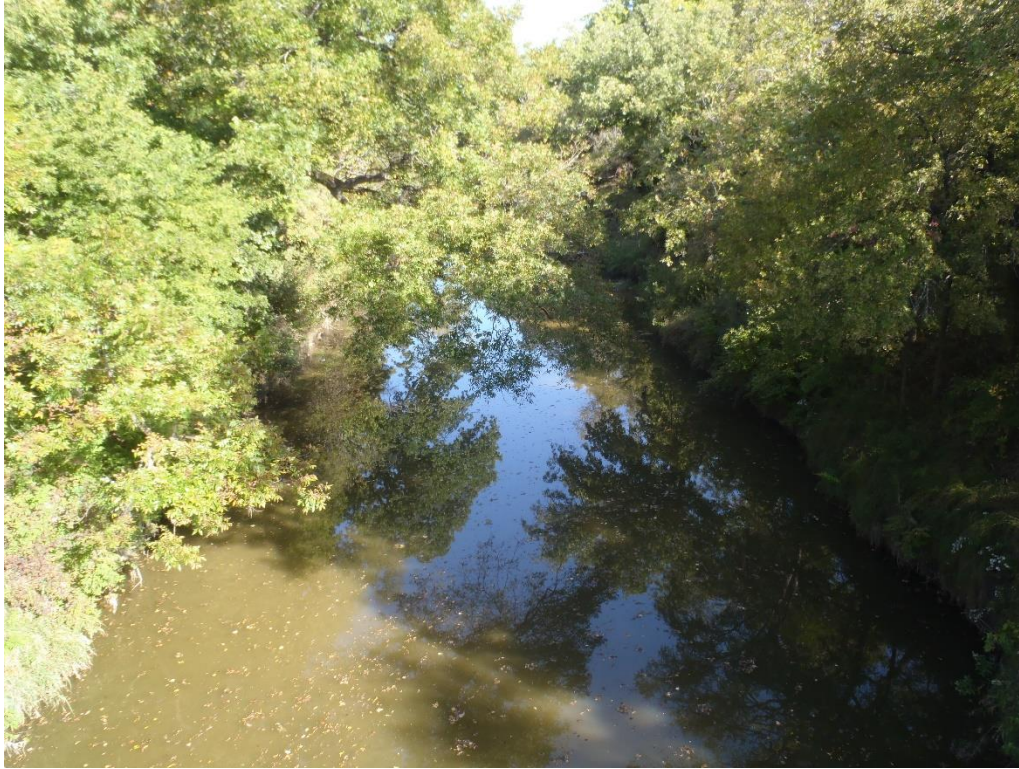
Figure 6 Station 15770, Lampasas River at Lampasas CR 2925, looking upstream from sampling location on October 13, 2020.

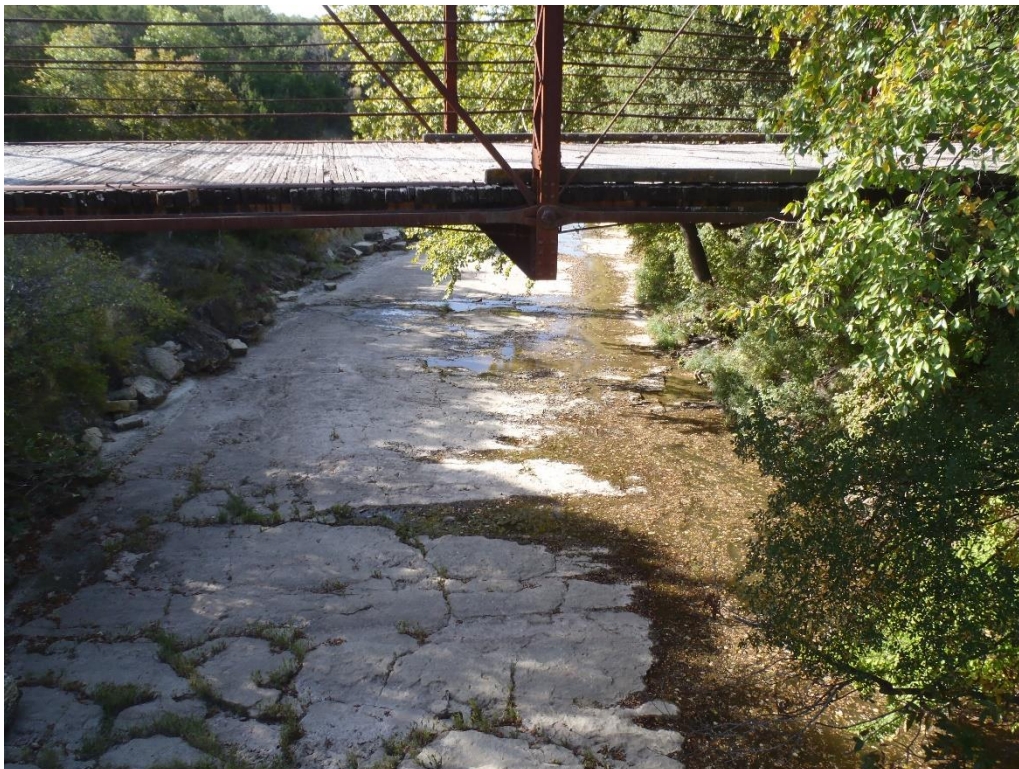
Figure 7 Station 15770, Lampasas River at Lampasas CR 2925, looking downstream from sampling location on October 13, 2020.

The Lampasas River at Lampasas County Rd 2925 monitoring station (station 15770, **Error! Reference source not found.** and Figure 7) is located in northern Lampasas County approximately 2.5 miles downstream of the Bennett Creek confluence. The upstream drainage area is primarily rangeland and is 279 square miles. Like the station upstream, flows at this site were typically low during the summer and early fall months. However, the stream was flowing for all 13 routine sample collections, except for the sample collected on August 11, 2020.

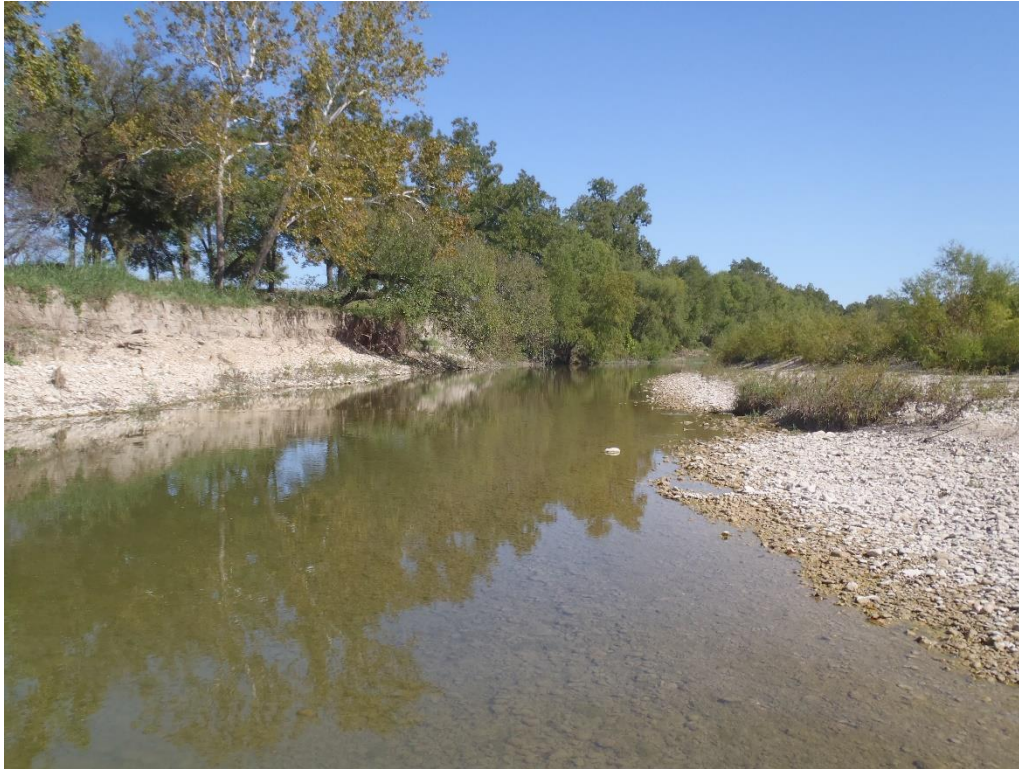
Figure 8 Station 16404, Lampasas River at Lampasas FM 2313, looking upstream from sampling location on October 13, 2020.

The Lampasas River at FM 2313 monitoring station (station 16404, Figure 8 and Figure 9) is located in southern Lampasas County approximately 2.8 miles upstream of the Sulphur Creek confluence. The upstream drainage area is primarily rangeland and encompasses 614 square miles. Due to the larger drainage area, this station was flowing during collection of all 13 routine sampling events.

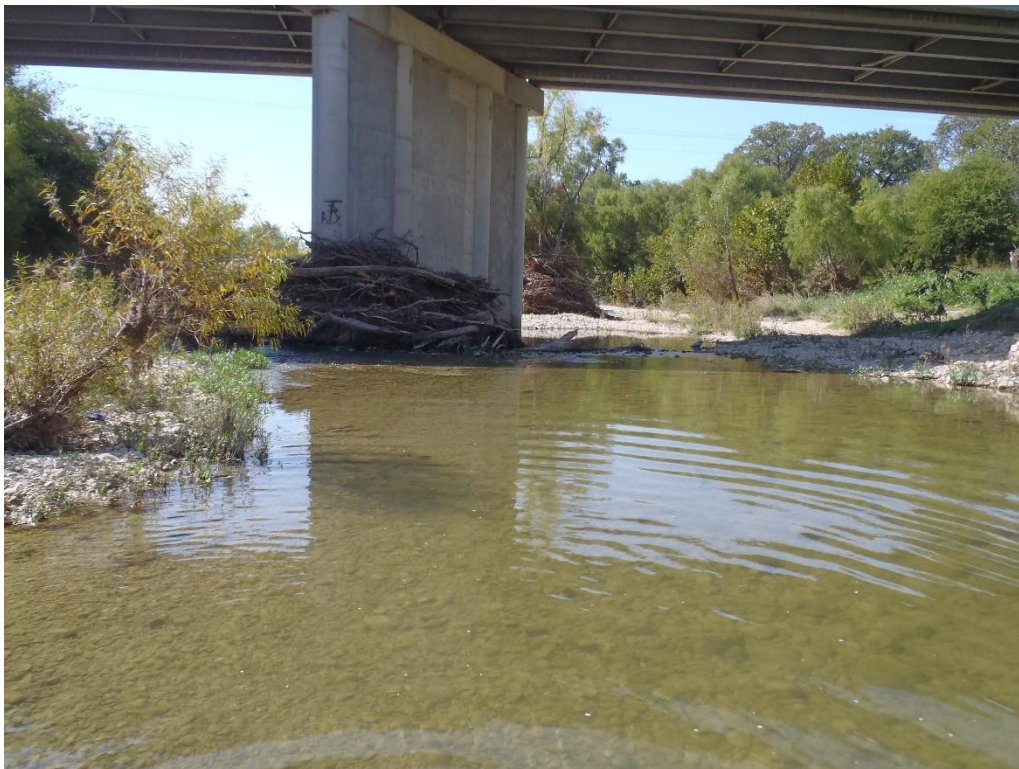
Figure 9 Station 16404, Lampasas River at Lampasas FM 2313, looking downstream from sampling location on October 13, 2020.

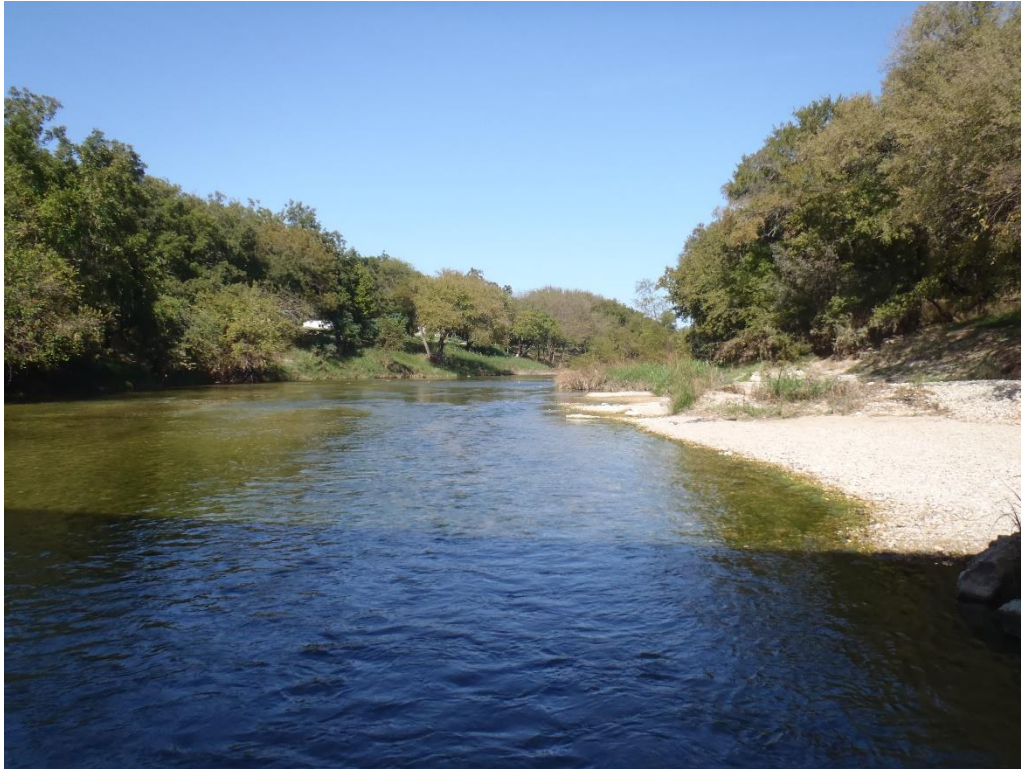
Figure 10 Station 11897, Lamppasas River at US 190, looking upstream from sampling location on October 13, 2020.

The Lampasas River at US HWY 190 monitoring station (station 11897, Figure 10 and Figure 11) is located in southern Lampasas County approximately 0.8 miles downstream of its confluence with Sulphur Creek. The upstream drainage area is primarily rangeland although its summer

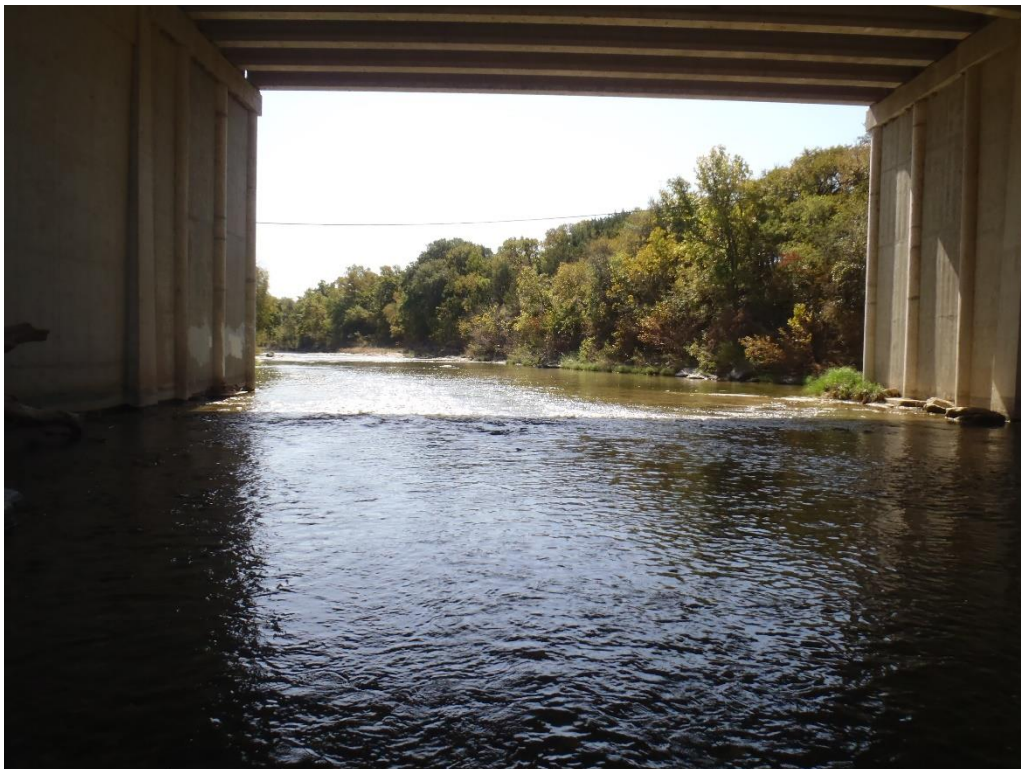
Figure 11 Station 11897, Lamppasas River at US 190, looking downstream from sampling location on October 13, 2020.

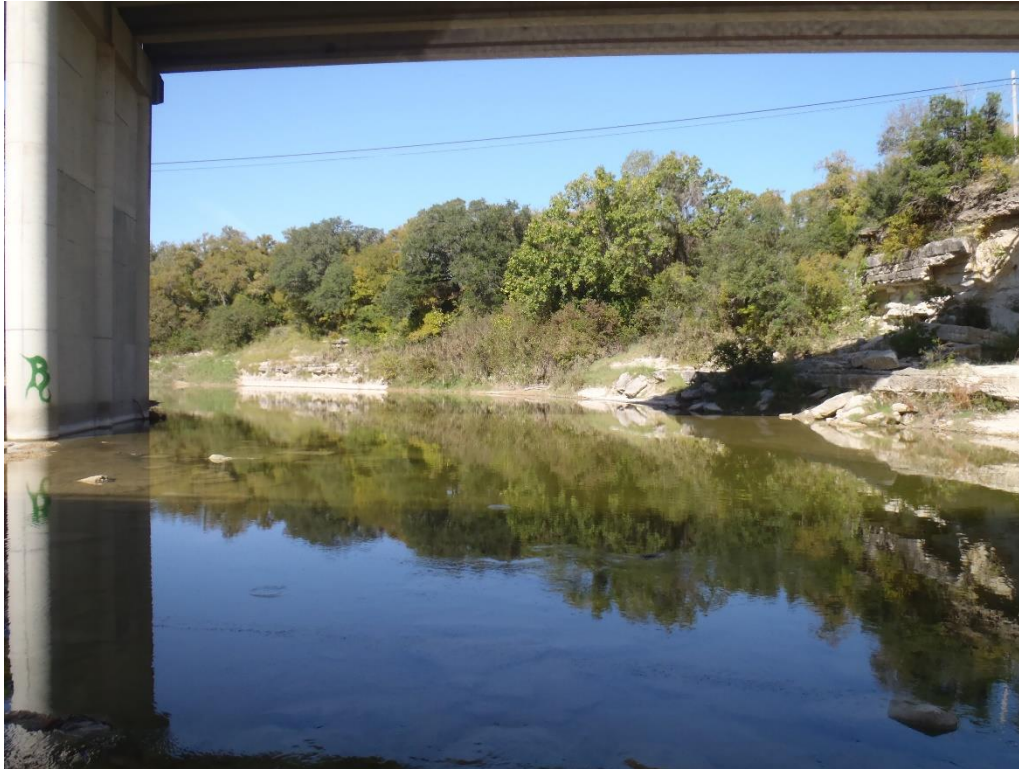
Figure 12 Station 11896, Lampapas River at HWY 195, looking upstream from sampling location on October 13, 2020.

The Lampasas River at State HWY monitoring station (station 11896, Figure 12 and Figure 13) is located in eastern Bell County, approximately 7 miles upstream of its confluence with Stillhouse Hollow Lake. The upstream drainage area is primarily rangeland, but the area also includes drainage from tributaries that encompass the Cities of Lampasas, Kempner, Copperas Cove, and Killeen. This is the most downstream station for the Lampasas River. The total drainage area for this station is 1,195 square miles. This site was flowing for all 13 routine sampling events for this project.

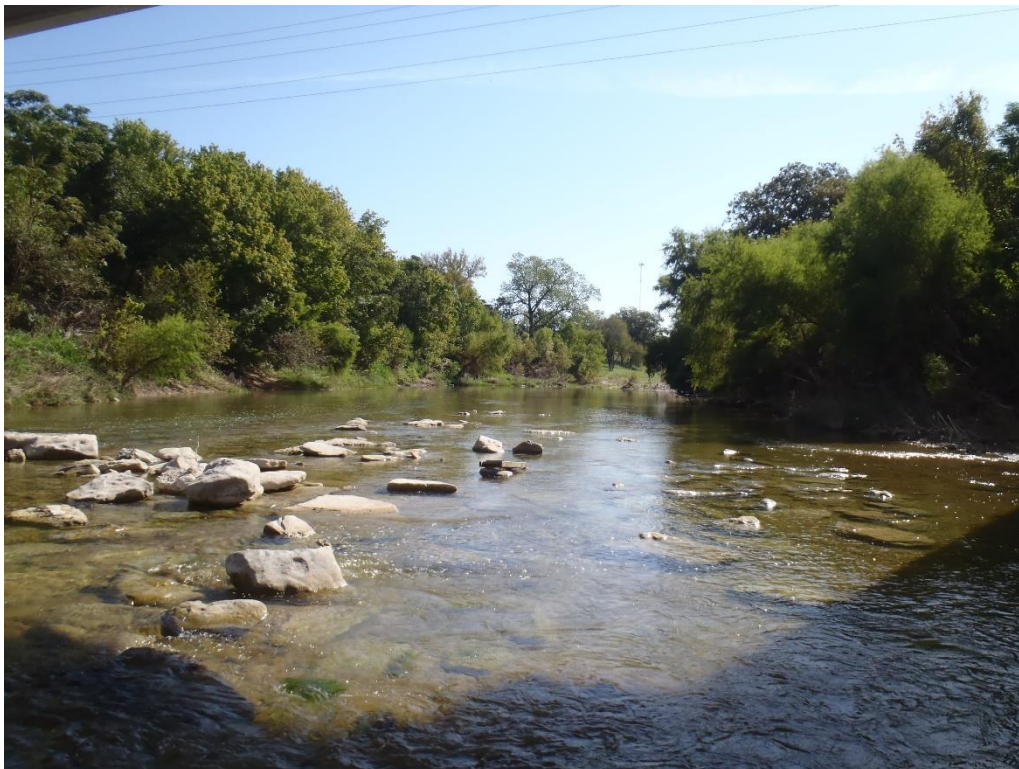
Figure 13 Station 11896, Lampapas River at HWY 195, looking downstream from sampling location on October 13, 2020.

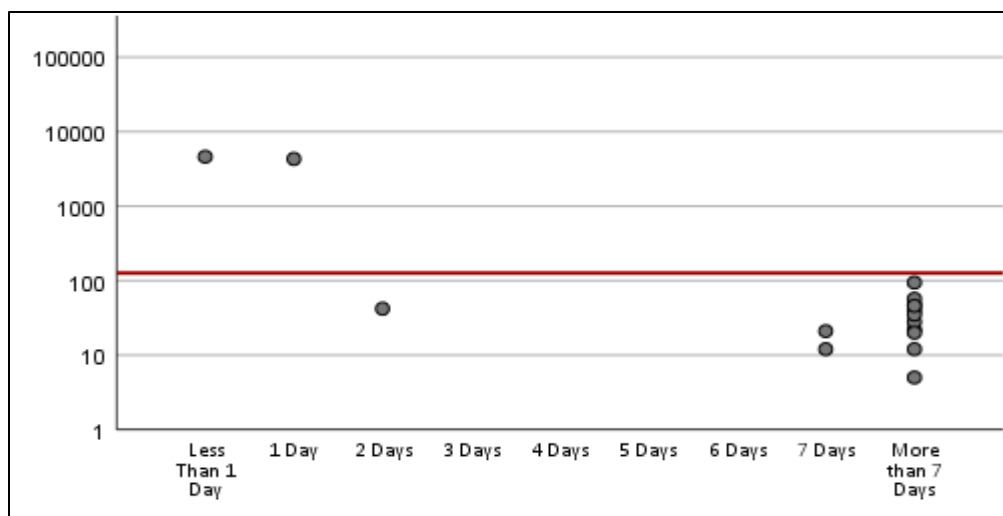
Figure 14A-E Log of E. coli plotted against DSLP for each sample on the mainstem of the Lampasas River.

(A)
Lampasas River
at US 84
Station 15762

(B)
Lampasas River
at Lampasas CR 2925
Station 15770

(C)
Lampasas River
at FM 2313
Station 16404

(D)
Lampasas River
at US 190
Station 11897

(E)
Lampasas River
at HWY 195
Station 11896

Although a 13-month sampling period is not temporally robust enough for most statistical analysis, it is interesting to look at the relationship between *E. coli* and the Days Since Last Precipitation (DSLPP) parameters. The following figures (A-E) illustrate the (log of) *E. coli* sample collected plotted on the X axis against the number of days since last precipitation on the Y axis. The red line illustrates the state standard of 126 cfu/100mL). As you move downstream, the number of samples that exceed 126 cfu/100mL during drier periods (more than 7 days since last precipitation) decreases. This may indicate that as baseflow increases, the *E. coli* concentration decreases. This same trend was seen while analyzing the data collected during the previous project as well.

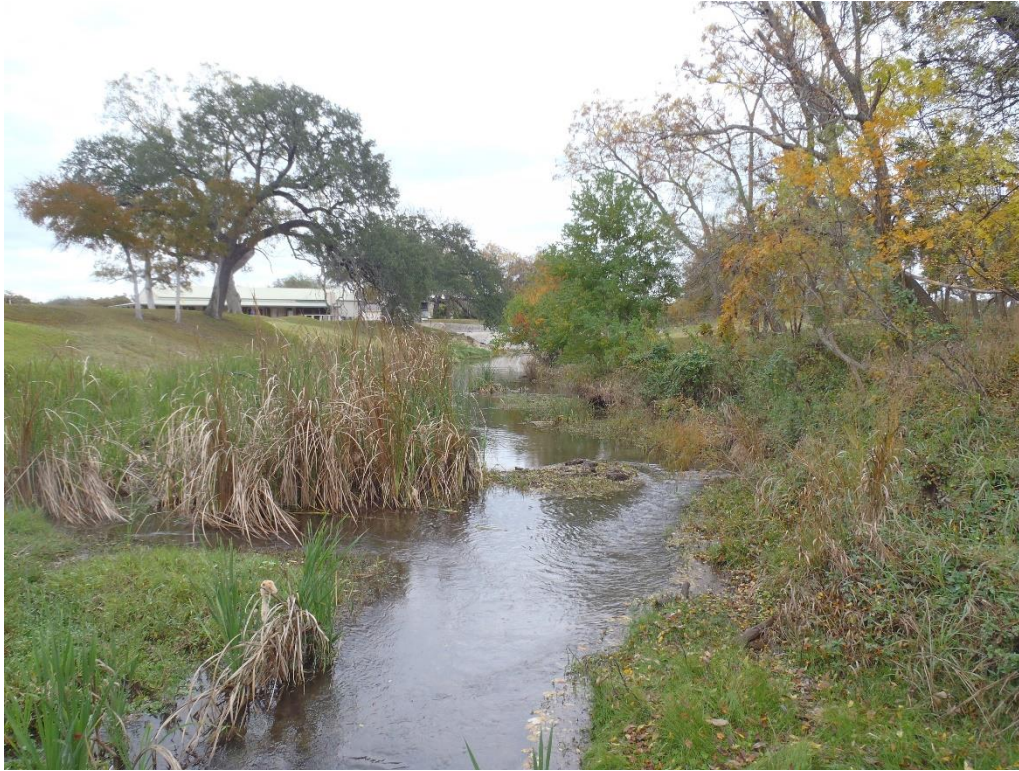
Figure 16 Station 18782, Sulphur Creek at Naruna Road, looking upstream from sampling location on November 10, 2020.

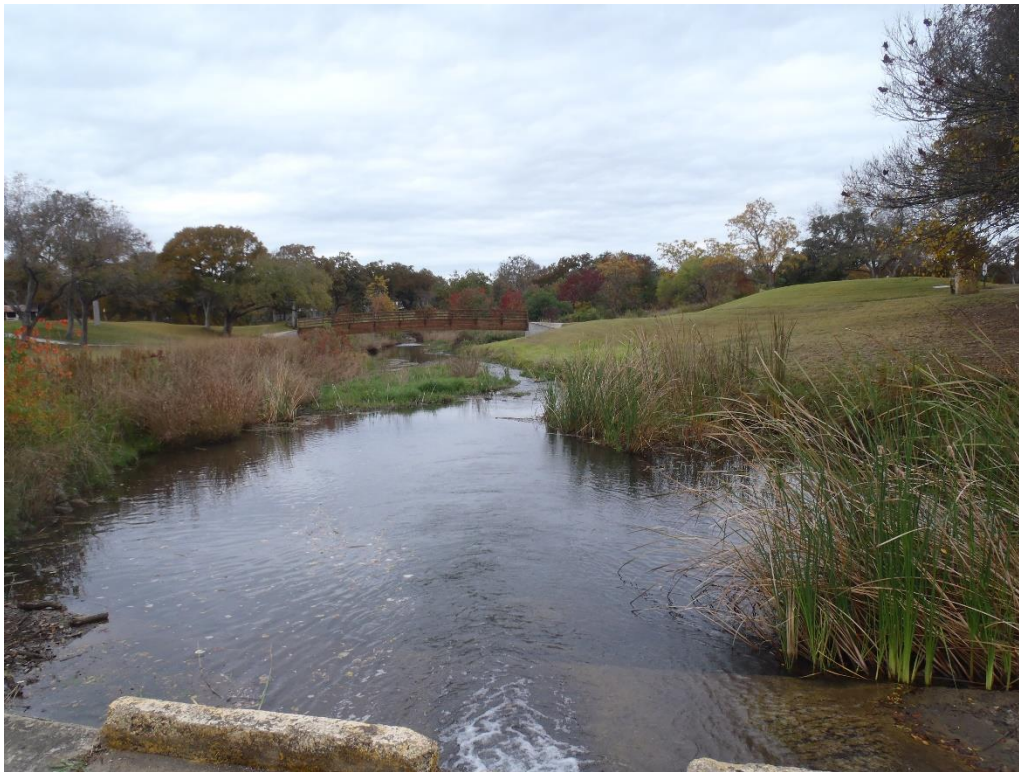
Figure 17 Station 18782, Sulphur Creek at Naruna Road, looking downstream from sampling location on November 20, 2020.

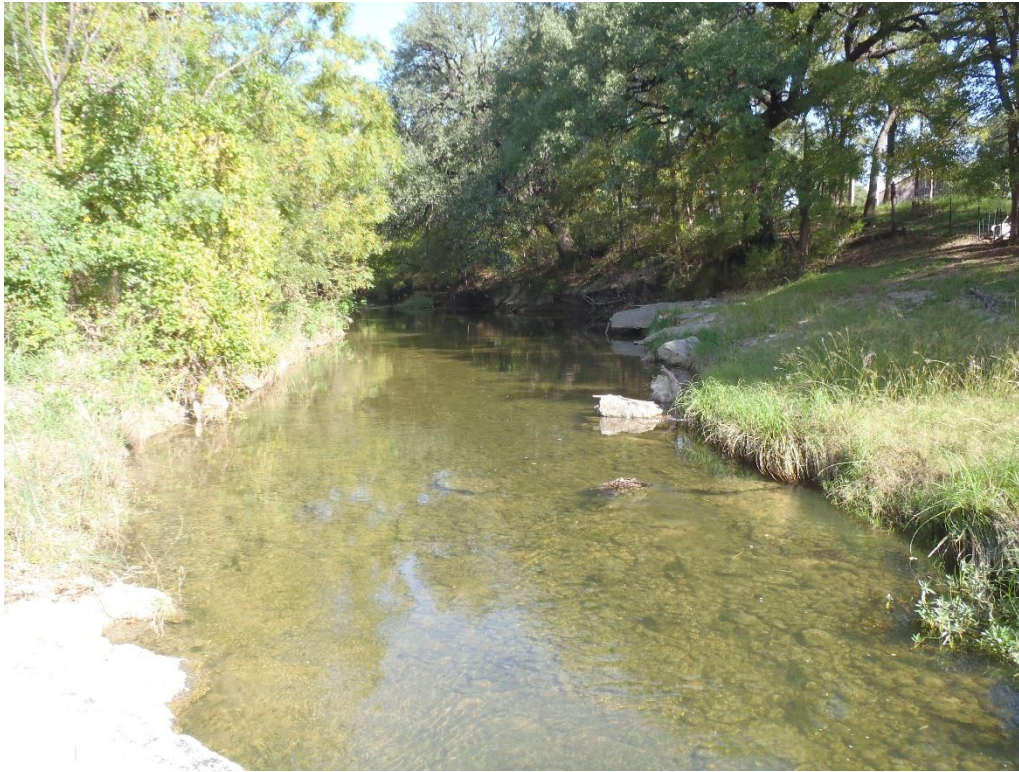
Figure 18 Station 15781, Sulphur Creek at Lampasas CR 3010, looking upstream from sampling location on October 13, 2020.

The Sulphur Creek at Lampasas County Rd 3010 monitoring station (station 15781, Figure 18 and Figure 19) is located in southern Lampasas County, several miles east of the city of Lampasas. This station is down stream from station 18782 and has a drainage area of 107 square miles.

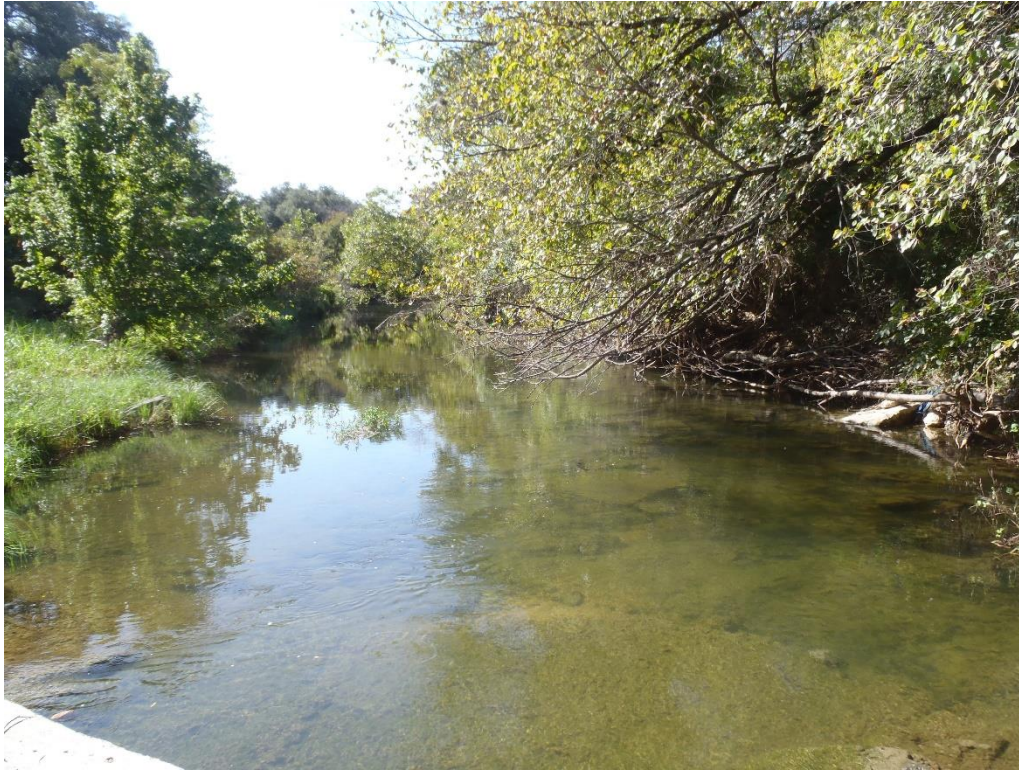
Figure 19 Station 15781, Sulphur Creek at Lampasas CR 3010, looking downstream from sampling location on October 13, 2020.

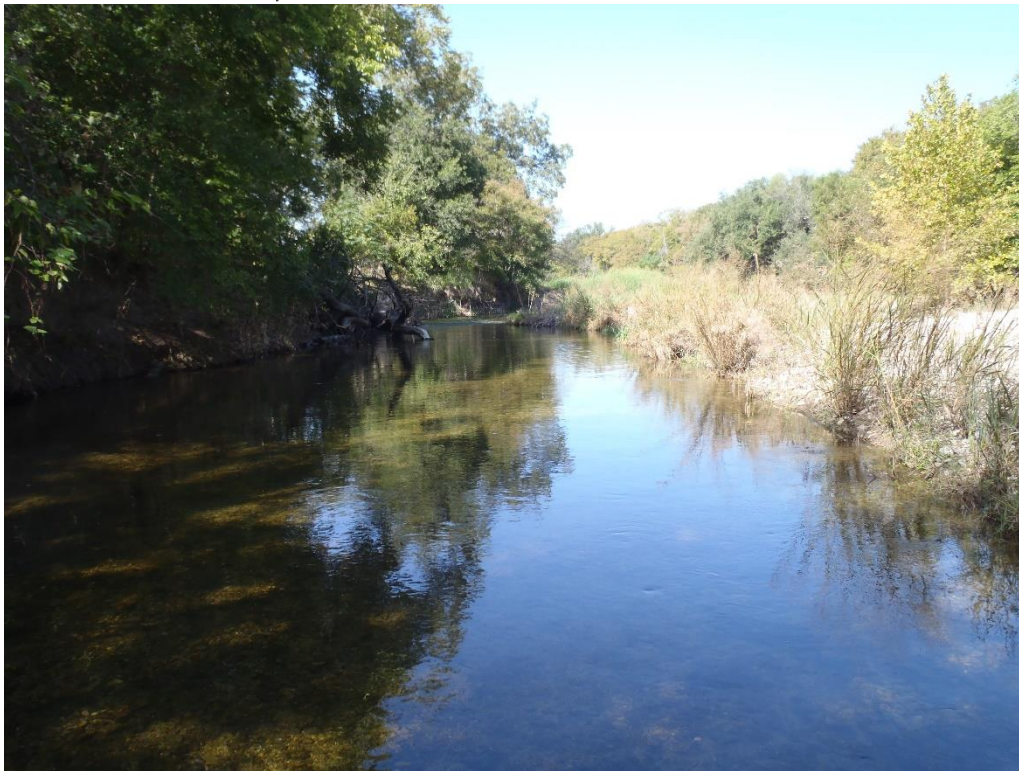
Figure 20 Station 15250, Sulphur Creek at CR 3050, looking upstream from sampling location on October 13, 2020.

The Sulphur Creek at CR 3050 monitoring station (station 15250, Figure 20 and Figure 21) is located in southern Lampasas County, approximately 1.5 miles upstream from Sulphur Creek's confluence with the Lampasas River. This station the most downstream site on Sulphur Creek and has a drainage area of 130 square miles.

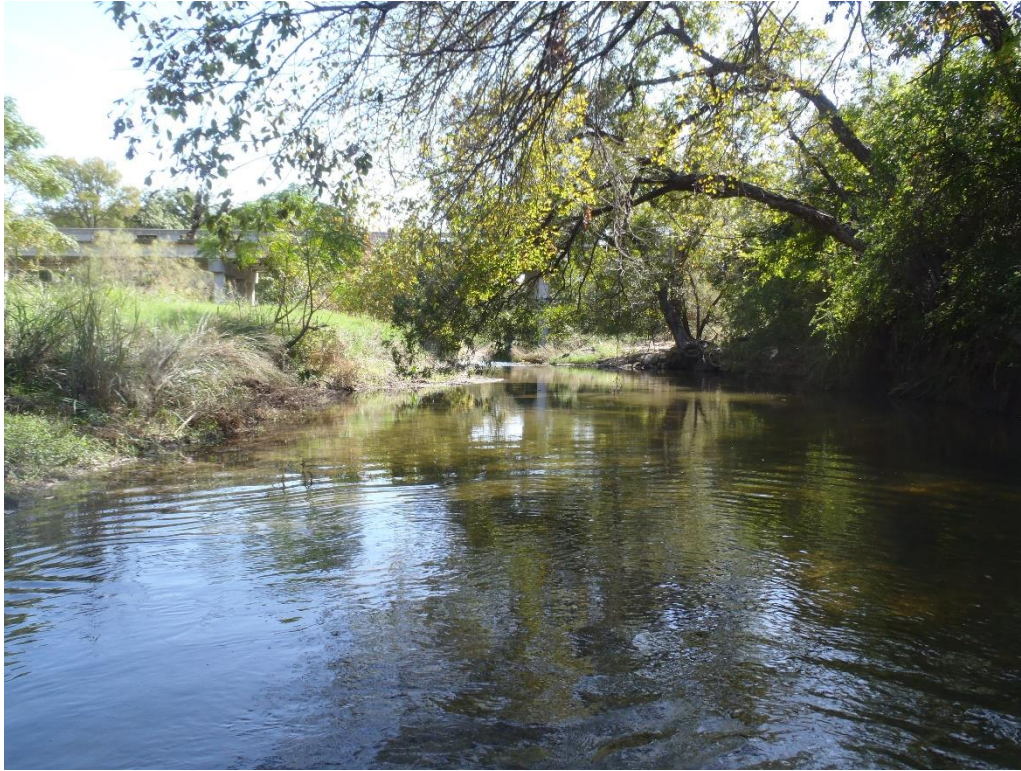
Figure 21 Station 15250, Sulphur Creek at CR 3050, looking downstream from sampling location on October 13, 2020.

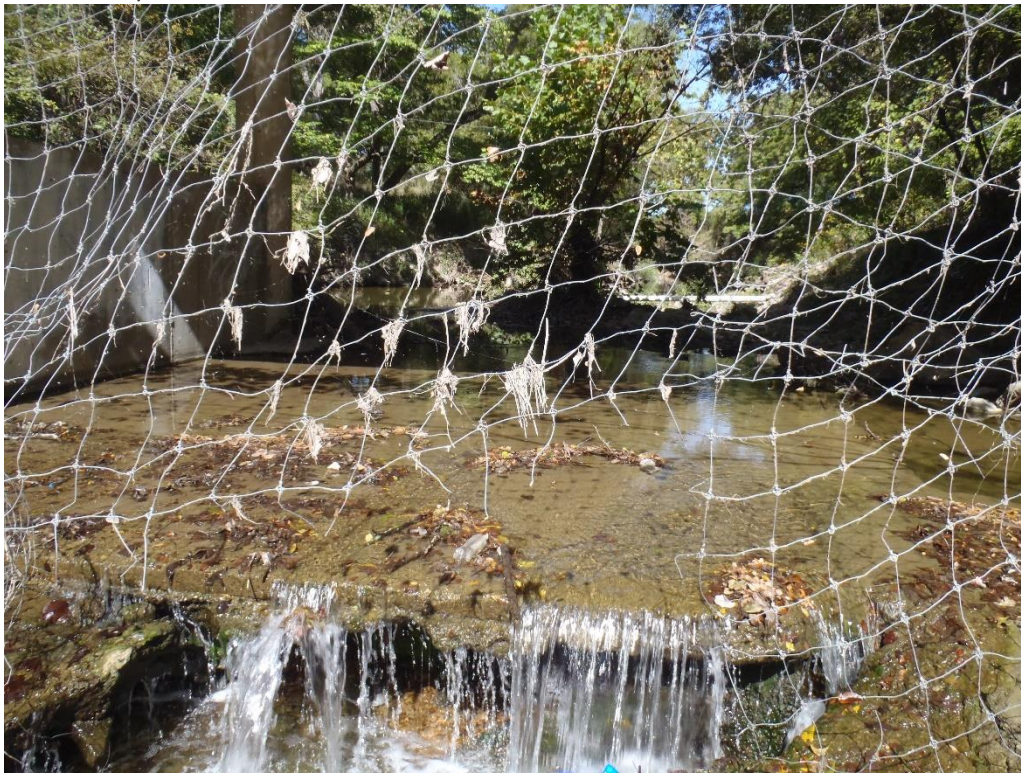
Figure 22 Station 21016 Clear Creek at Oakalla Road, looking upstream from sampling location on October 13, 2020.

The Clear Creek at Oakalla Road monitoring station (station 21016, Figure 22 and Figure 23) is located in eastern Burnet County, approximately 0.5 miles upstream from its confluence with the Lampasas River. Clear Creek originates in southwestern area of the city of Copperas Cove and is partially residential/urban and partially rangeland land use. The drainage area for this station is 30 square miles.

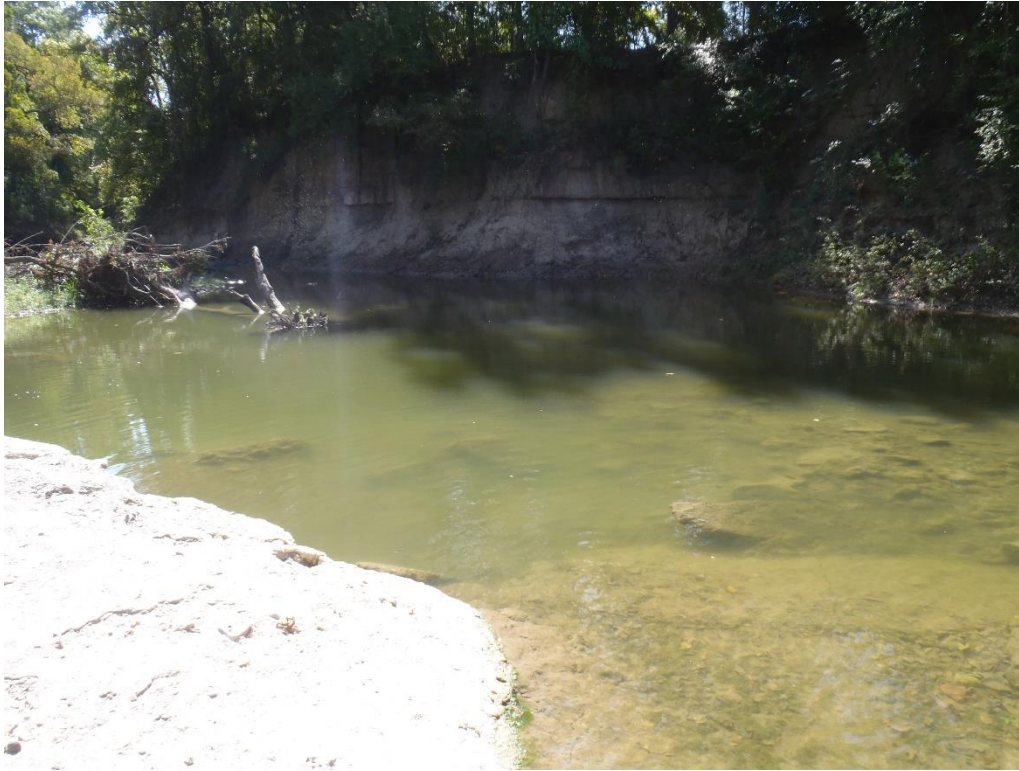
Figure 23 Station 21016 Clear Creek at Oakalla Road, looking downstream from sampling location on October 13, 2020.

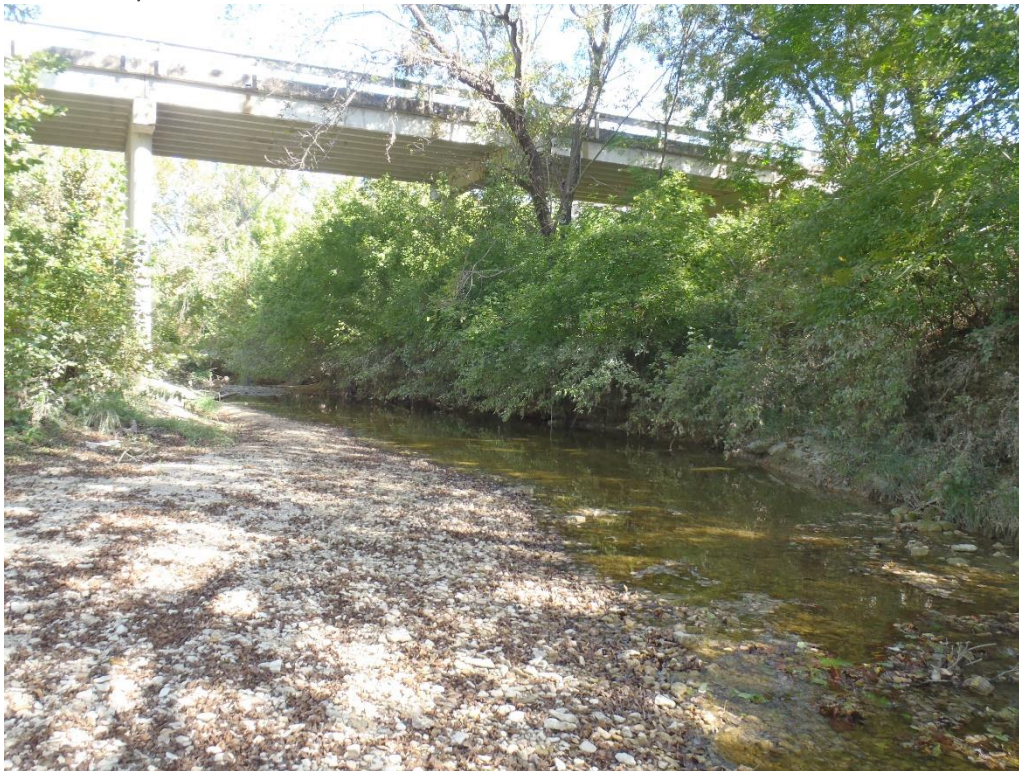
Figure 24 Station 18759, Reese Creek at FM 2670, looking upstream from sampling location on October 13, 2020.

The Reese Creek near FM 2670 monitoring station (station 18759, Figure 24 and Figure 25) is located in western Bell County, approximately 0.4 mile upstream from its confluence with the Lampasas River. Reese Creek originates in southwestern area of the city of Killeen and is partially residential/urban and partially rangeland land use. The drainage area for this station is 29 square miles.

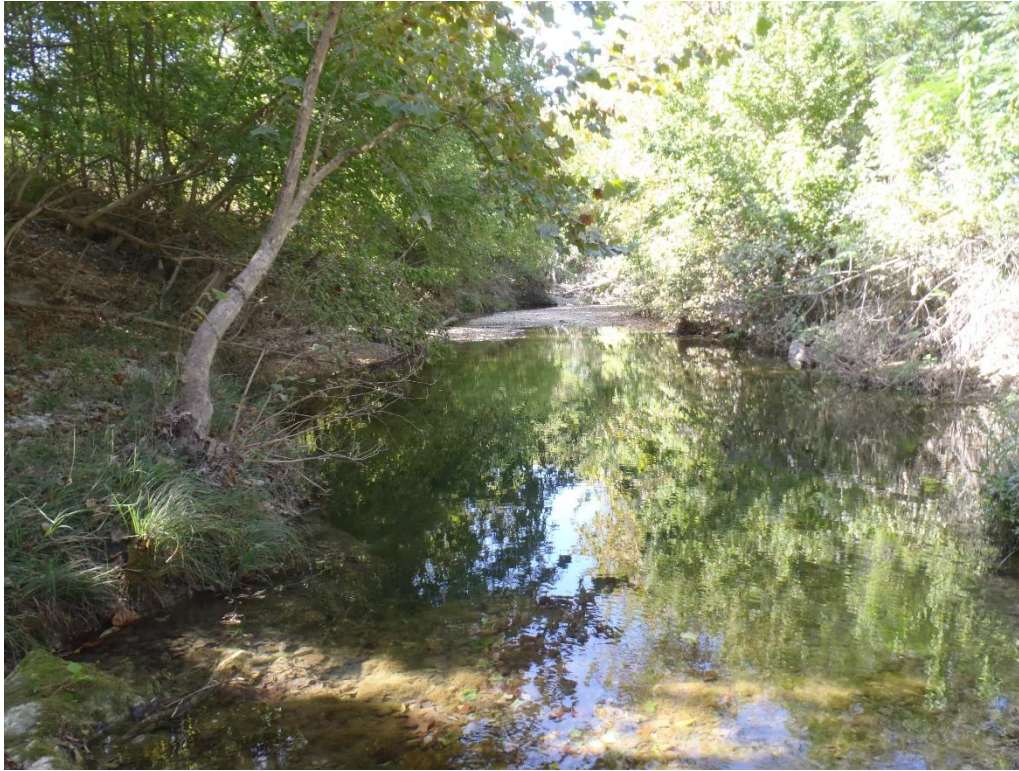
Figure 25 Station 18759, Reese Creek at FM 2670, looking downstream from sampling location on October 13, 2020.

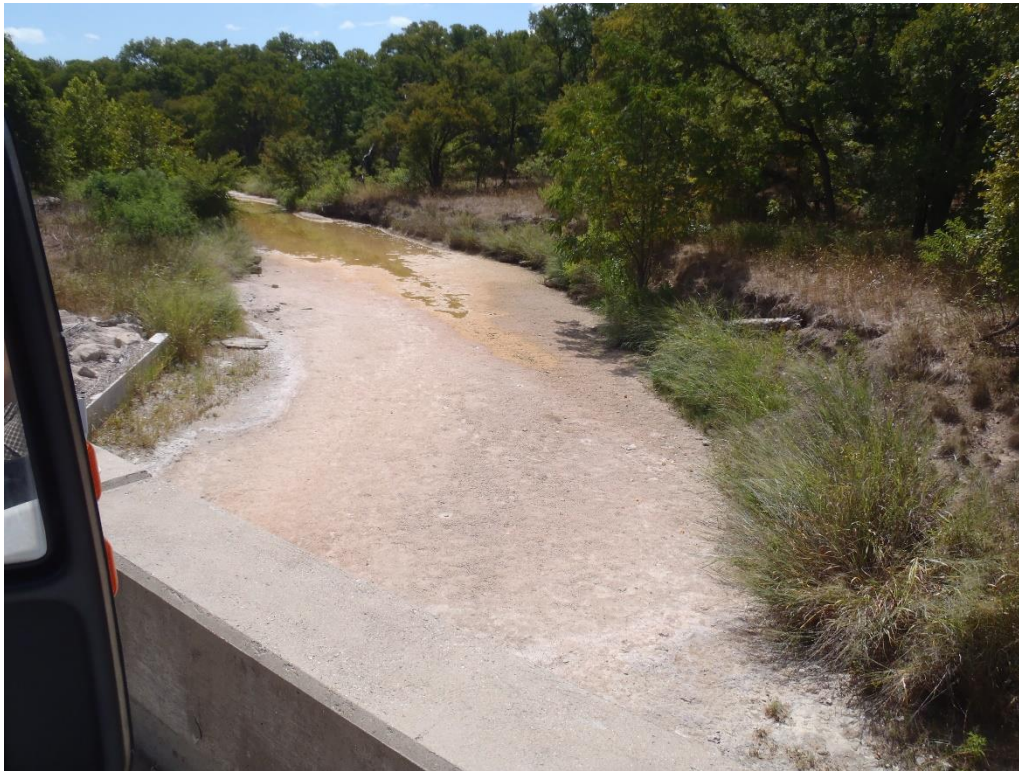
Figure 27 Station 18334, North Fork Rocky Creek at FM 963 on August 11, 2020.

As mentioned in the project overview, the collection of five 24-Hr DO samples at North Fork Rocky Creek (station 18334, Figure 27) was included in this project. North Fork Rocky Creek was a part of a special study conducted by TCEQ in 2009. TCEQ evaluated sources of oxygen-demanding materials and their impacts on dissolved oxygen in the creek. In addition to the collection of 24-hour dissolved oxygen data over a two-year period between August 2002 and September 2004, biological data was also collected. Data indicated that it supports a relatively healthy biological community, better than that which would be expected based on the results of the dissolved oxygen monitoring. In 2010, the TCEQ adopted revised, site-specific standards for dissolved oxygen in Rocky Creek.
